Test report no.: 14924

Plug and key - Salt spray test

Test procedure used:	IEC60068-2-11 - Basic environmental testing procedures: Part 2: Tests - Test Ka Salt Mist
Type of test(s):	Salt spray test
Test result:	Compliant. See test results
Test item description:	Plug and key
Manufacturer:	YeboTech
Model no.:	N/a
Serial no.:	N/a
Remarks:	None
Date received:	2017-09-11
Test location:	Gerotek Test Facilities
Test commencement date:	2017-09-11
Test completion date:	2017-09-15
Test witnessed by:	N/a
Ambient temperature:	23°C ±6°C

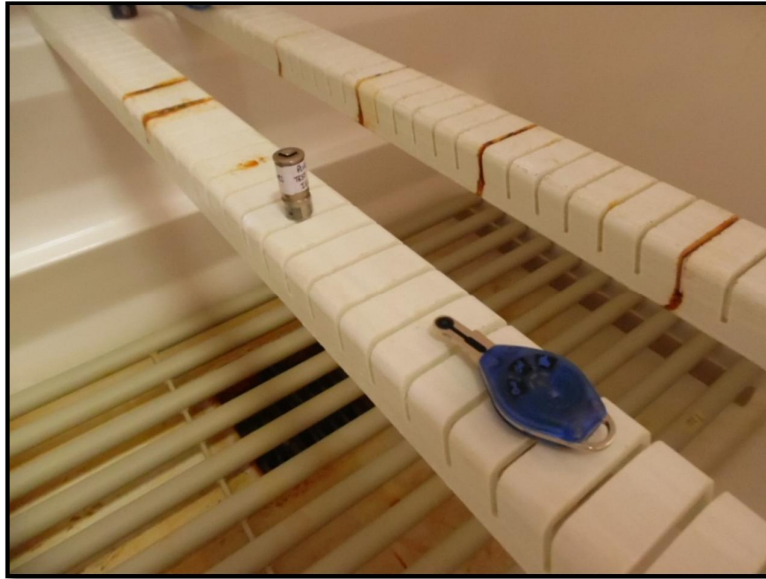
Prior to the salt spray test

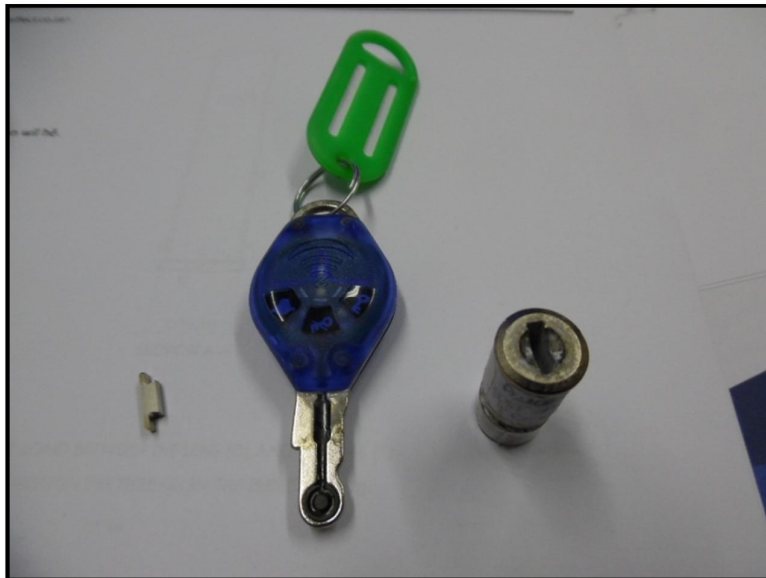
No corrosion or rust were recorded when the plug and key was visually inspected upon completion of the test. Both the plug and key was functionally tested using another plug and key (not-tested) and the results obtained were satisfactory.

Upon completion of the salt spray test
